INSTALLATION RESTORATION PROGRAM

SITE INVESTIGATION REPORT VOLUME I

182 Airlift Wing
Illinois Air National Guard, Greater Peoria Airport
Peoria, Illinois

June 1996

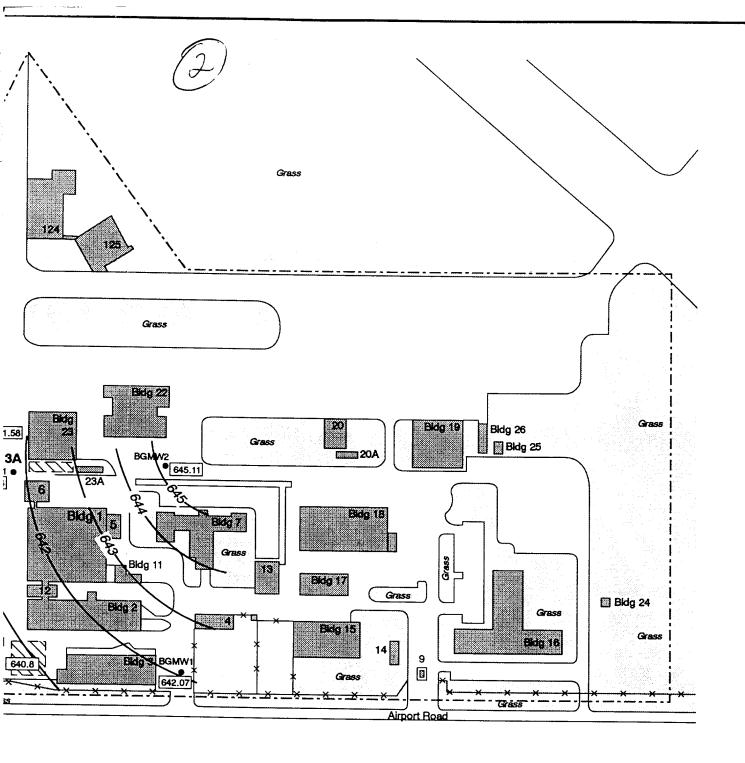
Facility Groundwate Elevation Map April 18, 1993

Groundwater elevation measurements were obtained from the four piezometers on December 13, 1992 and were used to create a facility-wide groundwater elevation map. These data were also used to select a down-gradient monitoring well location for Site 1 (Figure 3-1). After the installation of all SI monitoring wells, groundwater elevation measurements were obtained again on January 21, 1993 and April 18, 1993. The three rounds of groundwater elevation data all show similar flow directions. As illustrated on Figure 3-1, groundwater flow is to the southeast across Site 1 at an average hydraulic gradient of 0.007 ft/ft, and 1MW1 is located hydraulically down-gradient from the filter bed. Groundwater beneath Site 1 occurs at approximately 2 ft bgs. The average K value calculated

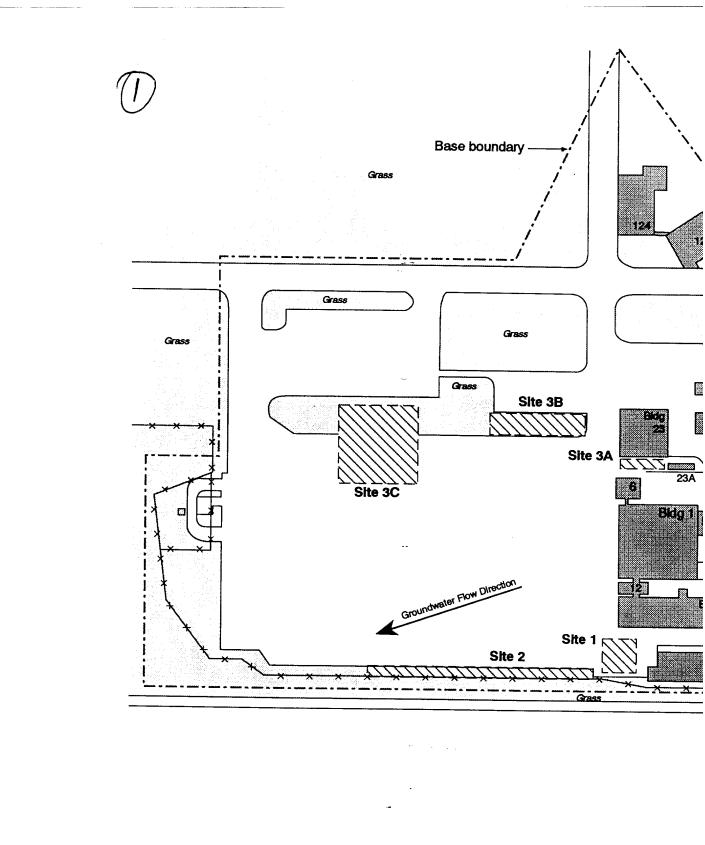
Facility Background Sampling Locations

Background surface and subsurface soil samples were collected on facility property, and submitted for laboratory analysis of VOCs, SVOCs, TPH, and TAL metals. The resulting analytical data were principally used to determine concentrations of inorganics in the native or undisturbed soils on base. Groundwater monitoring wells were installed in two of the background borings, hydraulically up-gradient of the sites of interest, and sampled for VOCs, SVOCs, TPH, and TAL metals. Groundwater concentrations from these wells were used as the facility background for groundwater in the shallow aquifer. Figure 3-2 presents the background sampling locations. The background soil and groundwater analytical results were

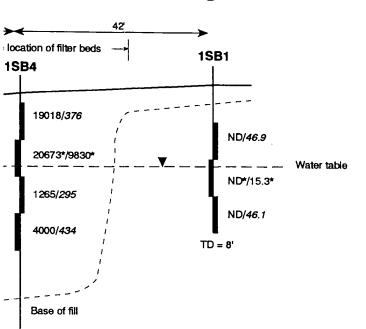
Explanation
	Soil sample interval
4000/434	PNA concentraction (µg/kg)/TPH concentration (mg/kg)
PNA	Polynuclear Aromatic Hydrocarbon compounds (μg/kg)
ТРН	Total Petroleum Hydrocarbon (mg/kj
ND	Not detected
NA	Not analyzed
	* Averaged concentration of sample and representative duplicate
Y	Water table
	Screened interval
V	ertical exaggeration 4:1

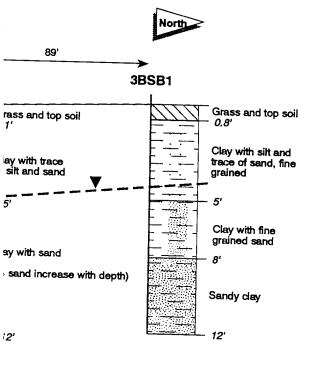
Figure 3-20

> Site 3: **Section 3B Cross Section**
